# UNIVERSITY OF HAWAII

## MEMORANDUM

SUBJECT: Redesign of multi-modal path along Wailua Beach

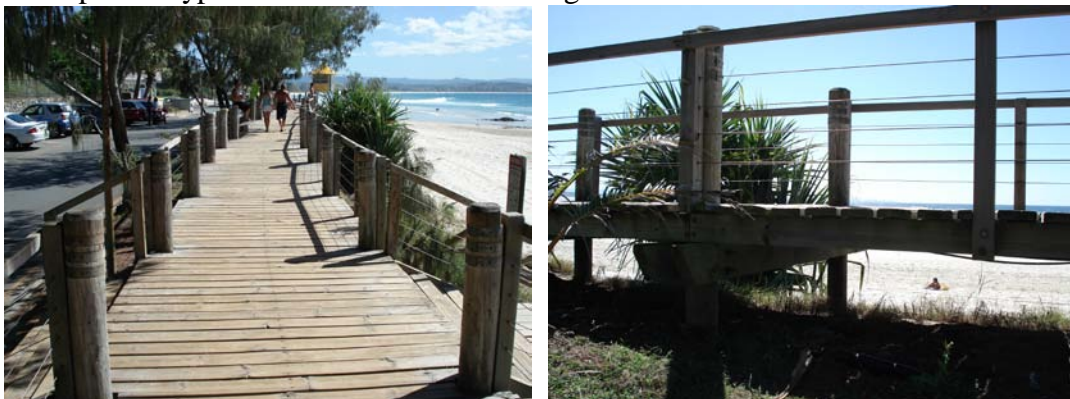
Examples of typical raised wood board designs:

As an alternative, we suggest that you look into a resilient raised wooden boardwalk design. This option may be less costly and easier to maintain than a concrete path over the long-term, given the probability of removal that may be needed. The height of a wooden boardwalk is flexible, and need not be extensive and I believe could be compatible with a highway barrier wall. Benefits of a raised boardwalk design include an accommodation strategy which allows for waves and erosion to migrate under the structure without causing damage or even effecting the use of the boardwalk. Raised boardwalks are commonly constructed in beach settings around the world and serve to provide reliable access to and along the beach with minimal, negligible even, impact to the beach processes at a fraction of the cost of reinforced concrete pathways that may require repair. Attached is an example Army Corps of Engineers technical note and design that could be modified for your purposes. We can also provide more detailed examples of similar boardwalk designs for your consideration.
